# Cleaning the Komsomolskoe Lake, Siberia using Geotube®

## Planning and Execution – Admir Russia, 2011

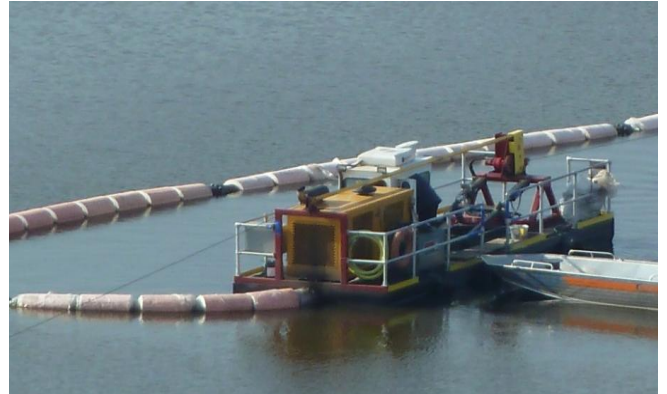
The DREDGER

1. Dredging of bottom sediments with a dredger with a discharge rate of 400 cu. m. per hour, into the Geotube® system.

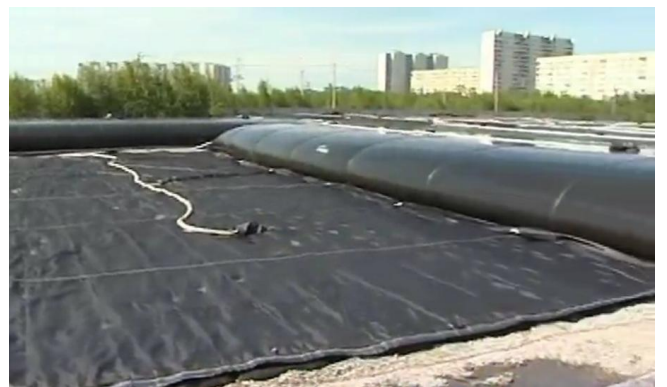
The Geotubes in the filling process

2. Adding polymers and mixing them into the sludge. The addition of polymers causes flocculation facilitates the filtering process.
3. The filtered water flowed through the Geotube® back to the lake without the need for additional treatment.
4. The filled Geotubes has been left in the site for further dewatering during the freezing winter months, after which additional water was expected to be extracted.

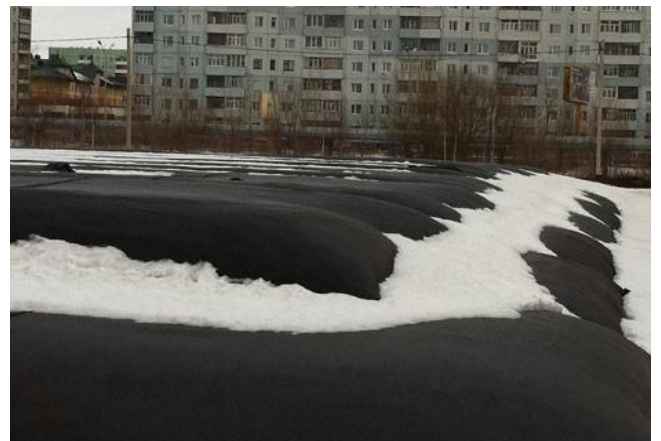
The Geotubes remained in place for continued dewatering during the winter
